# Rushville Walking/Pedestrian Path Strategies

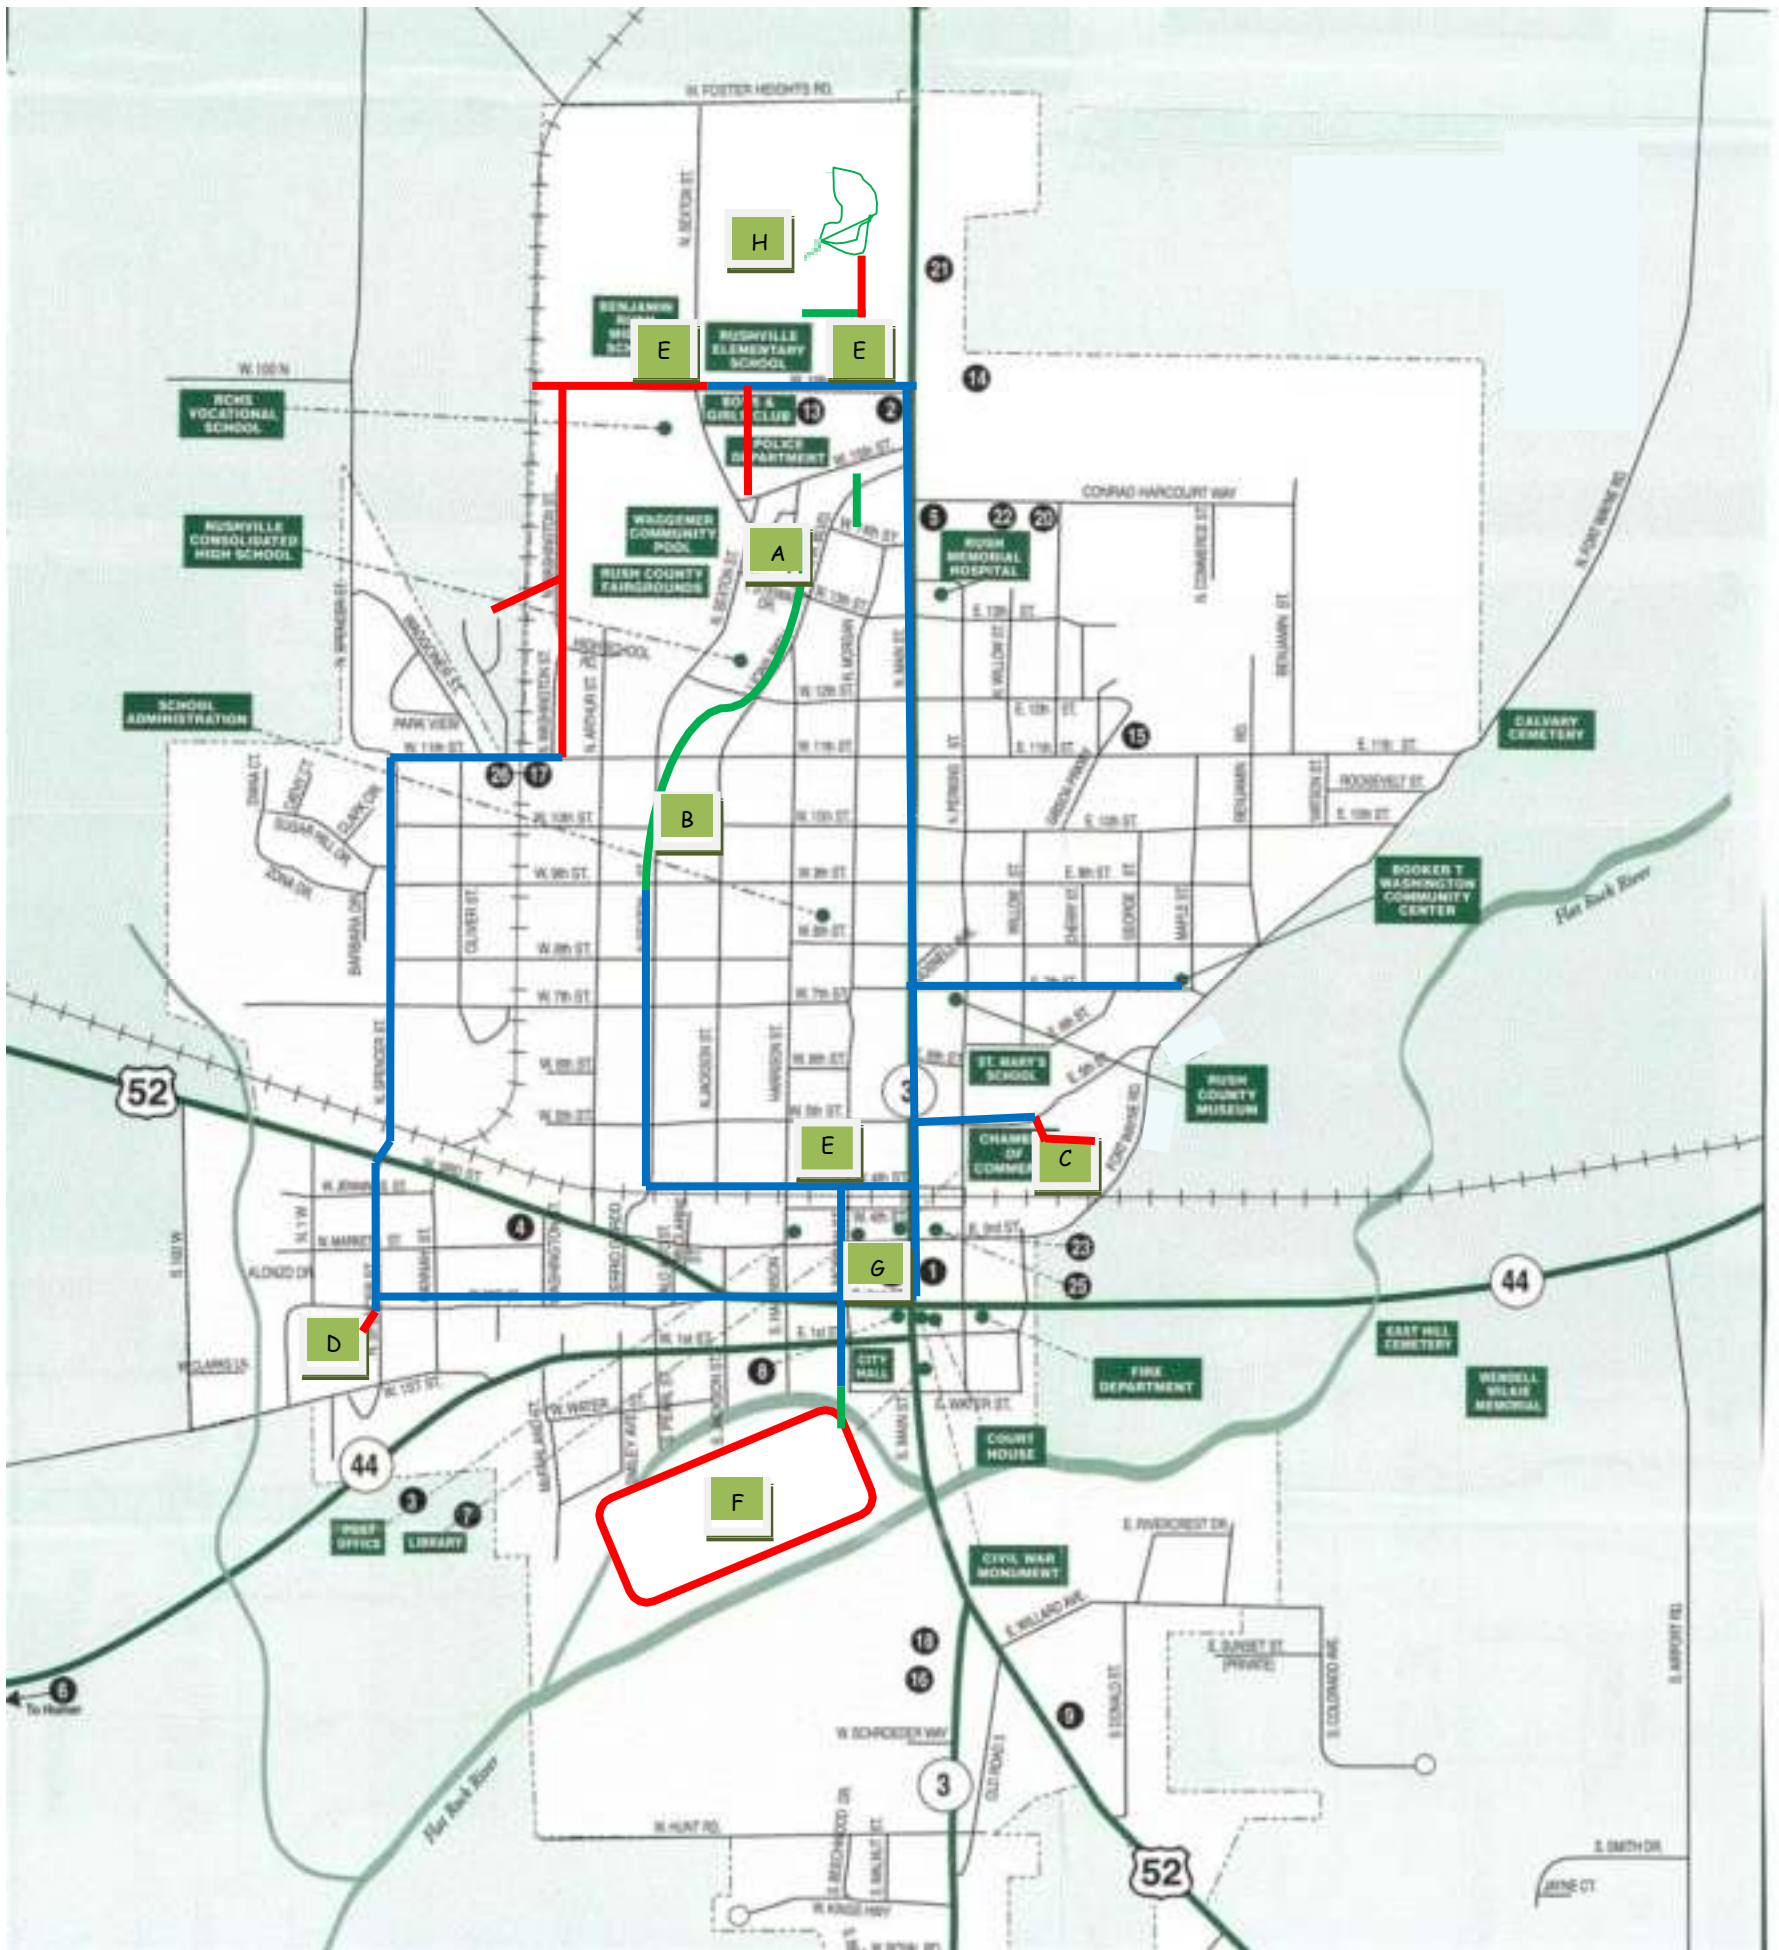
New trail/path ---- Sidewalks ---- Existing Trail/Path ---- School Nature Trail

| A. North Veterans Memorial Park | B. South Veterans Memorial Park | C. Community Park |
| D. Laughlin Park | E. School Playground | F. Riverside Park |

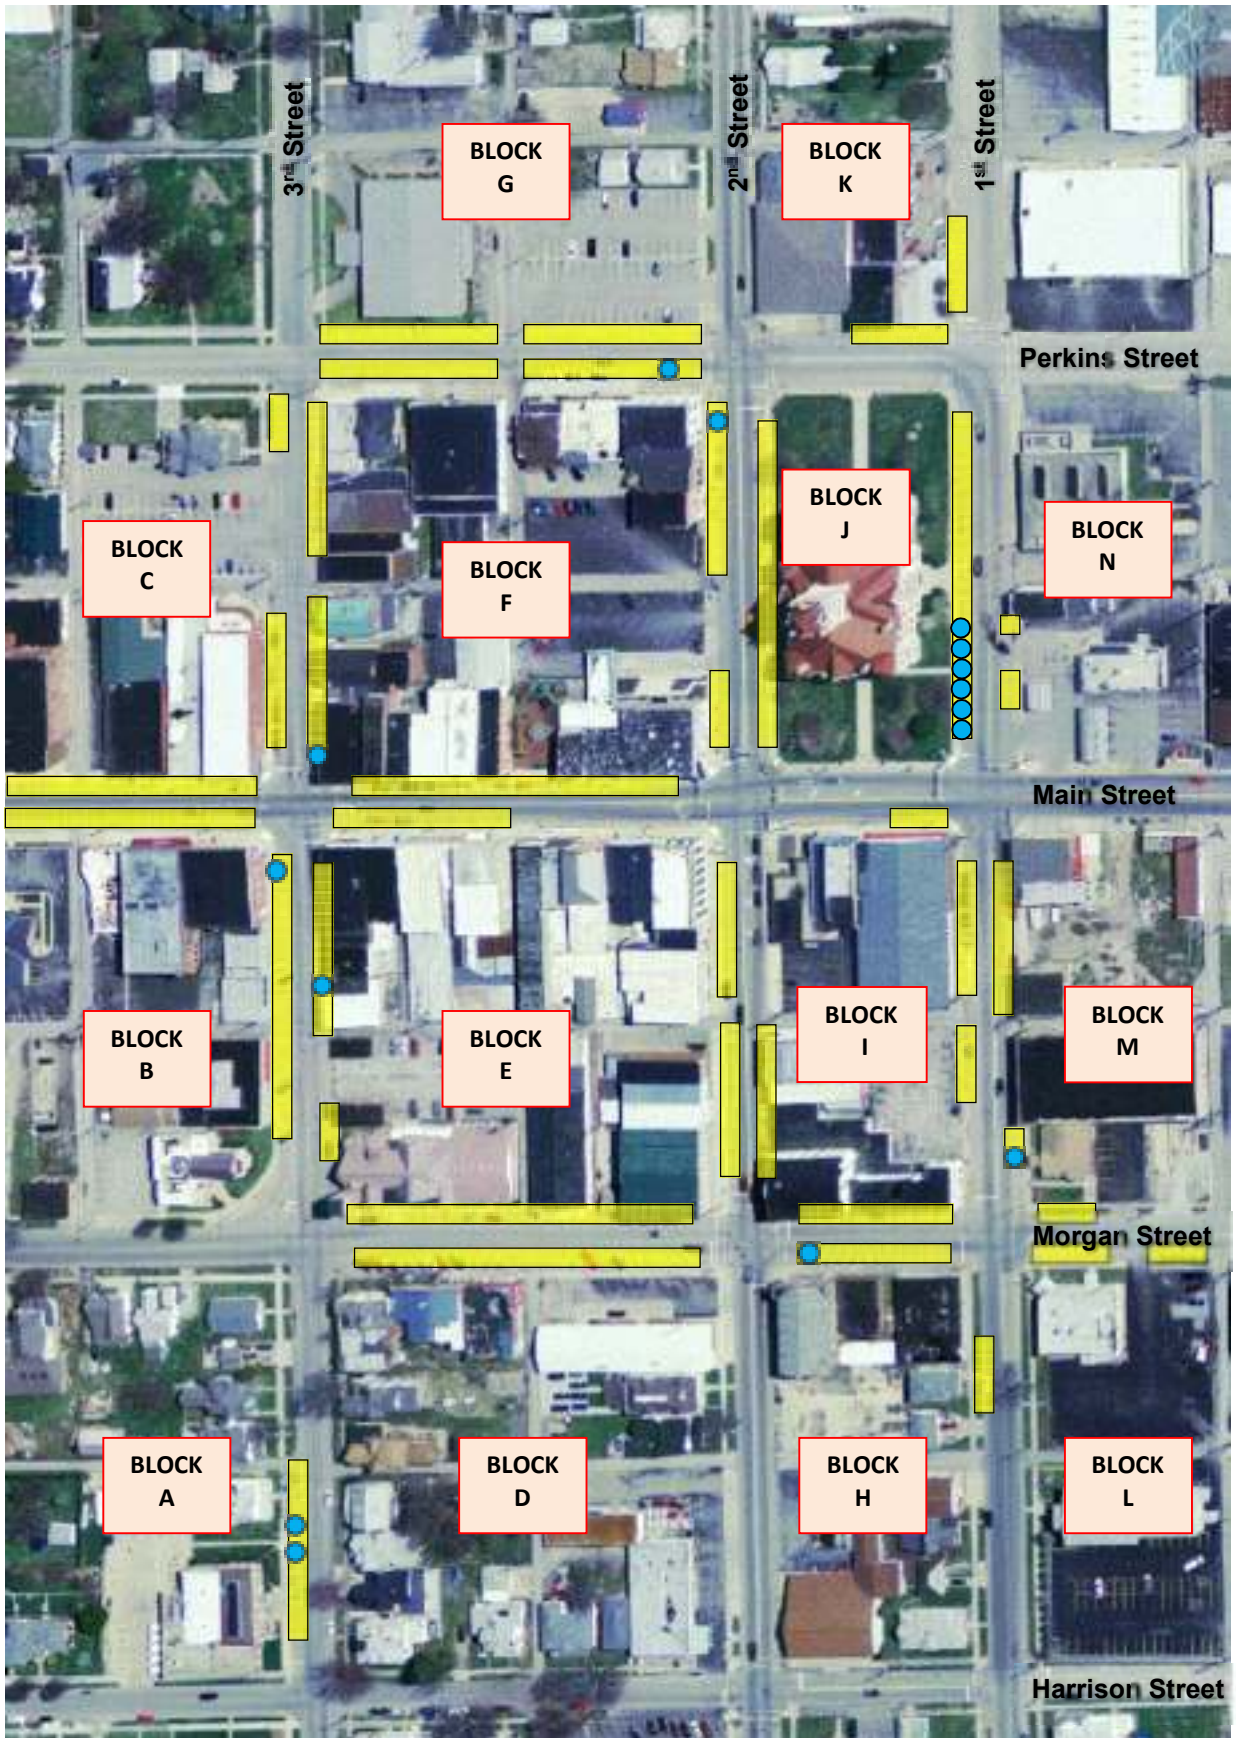
# On-Street Parking Map Key

= Barrier-Free Parking Space
